**Flood Control Project Maintenance
Levee Inspections**

Fall 2016 Levee Maintenance Deficiency Summary Report

Sutter Maintenance Yard Hamilton Bend

Waterway			Bank	Unit Miles
Unit No. 01 Feather River Hamilton Bend			Right	3.39
	Spring (March - May)	Summer (June - August)	(September - November) Fall	Winter (December - February)
Unit Maintenance Rating (Fall Only)			U	
Date of Inspection	4/5/2016 - 4/8/2016		9/7/2016 - 9/7/2016	
DWR Inspector	Sterling York		Sterling York	
Accompanied By	Shawn Freitag Sutter Maintenance Yard		Shawn Freitag Sutter Maintenance Yard

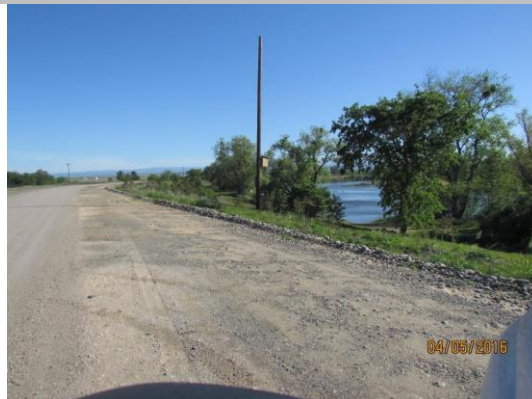
Photo 1 of 1 : FA_2016_ST0005_289_14_20160906_00003.jpg

LM Start	0.73	Rating **	M	Issue No.	14
LM End	0.91	Issue Type +	En	Location *	WS
Category	Earthen Levee			GPS Latitude/Longitude	
				Start	End
Item	Encroachments			39.450109 °	39.452643 °
				-121.640851 °	-121.640316 °
DWR ID	DWR_ST0005_01_s _ 2016_14				
Comment Code					
TR : Tree or limb					
Inspector Comment					
trees smaller than 4" in diameter at chest height should be removed before they get any bigger.

View looking upstream of trees. Small trees 4" in diameter at chest height should be removed before they get to big., Spring 2016.

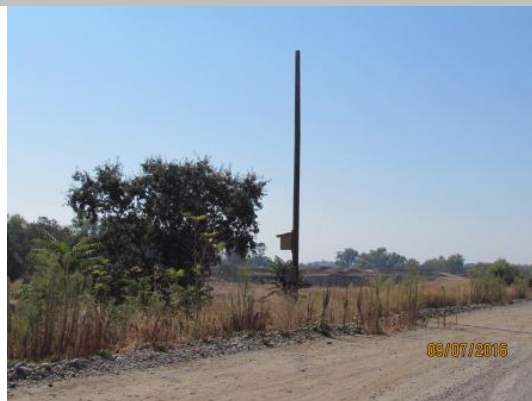
Photo 1 of 1 : FA_2016_ST0005_289_13_20160912_00016.jpg

LM Start	0.80	Rating **	M	Issue No.	13
LM End	0.80	Issue Type +	En	Location *	WS
Category	Earthen Levee			GPS Latitude/Longitude	
				Start	End
Item	Encroachments			39.450989 °	39.450989 °
				-121.640782 °	-121.640782 °
DWR ID	DWR_ST0005_01_s_2016_13				
Comment Code					
PO : Pole					
Inspector Comment					
Pole on waterside slope.

View of pole on waterside slope.

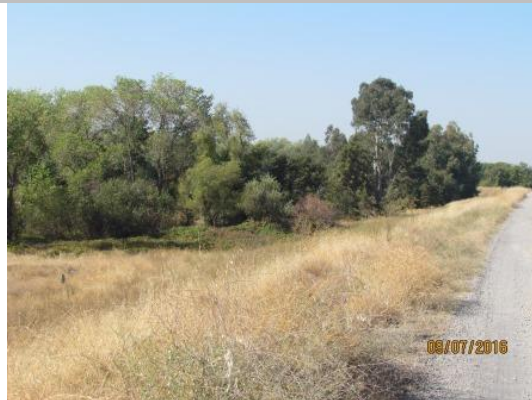
Photo 1 of 1 : FA_2016_ST0005_289_11_20160912_00015.jpg

LM Start	1.57	Rating **	M	Issue No.	11
LM End	2.23	Issue Type +	En	Location *	WS
Category	Earthen Levee			GPS Latitude/Longitude	
				Start	End
Item	Encroachments			39.459179 °	39.463828 °
				-121.636261 °	-121.625803 °
DWR ID	DWR_ST0005_01_f_2016_11				
Comment Code					
PR : Prunings					
Inspector Comment					
Annual grasses need to be maintained by contractor until levee is turned back over to ST0005.

View of waterside annual grasses that need to be maintained.

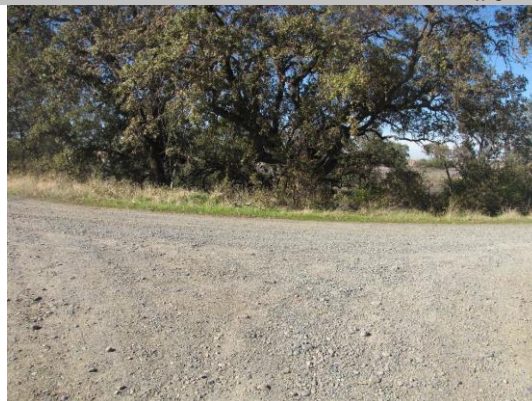
LM Start	3.25	Rating **	M	Issue No.	26
LM End	3.25	Issue Type +	En	Location *	WS
Category	Supplemental			GPS Latitude/Longitude	
				Start	End
Item	DWR UCIP Field Study			39.470269 °	39.470269 °
				-121.609229 °	-121.609229 °
DWR ID

FS_ID:47972
DS_ID:17044
EP_NO: N/A
Repair Type: Non-Urgent
Crossing Status: Indicator Found
UCIP Comments: 4/26/2016 Unable to access area near structure.5/14/2013 Same as last inspection.11/14/2012
Abandoned Structure: WS- reminisce of gates and concrete standpipe;
LS-reminisce of concrete headwall and pump station.
FIELD_STRUCT_DESC: *ABANDONED* [Western Canal Head Gate Inlet Structure] 1 of 2: 96-inch by 96-inch (8-foot by 8-foot) reinforced concrete culverts through the levee 25 feet below the crown. Three slide gates on the waterside (WS) end. Concrete stairs on the WS slope. Concrete headwall at both WS and landside (LS) toes. [Additional Reference(s): DWR Levee Log, 2005. USACE Sacramento O&M Manual 152, March 1957 (Station 170+00)]
FS Date: 5/3/2016 12:36:00 PM

View of levee crown looking downstream.

View of levee crown at right bend.

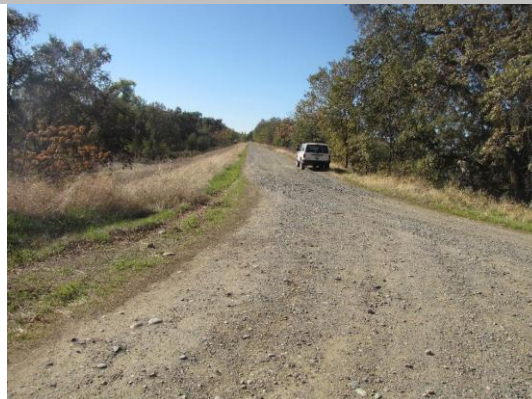
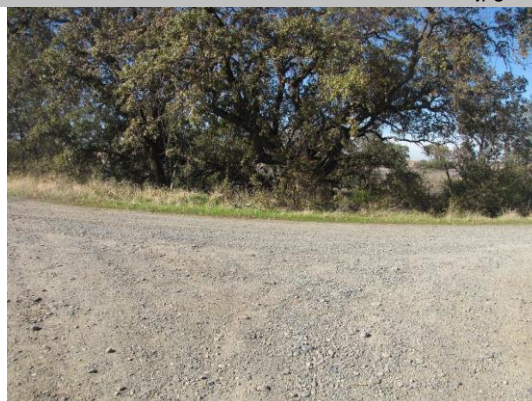
LM Start	3.25	Rating **	M	Issue No.	27
LM End	3.25	Issue Type +	En	Location *	WS
Category	Supplemental			GPS Latitude/Longitude	
				Start	End
Item	DWR UCIP Field Study			39.470269 °	39.470269 °
				-121.609229 °	-121.609229 °
DWR ID

FS_ID:47973
DS_ID:17056
EP_NO: N/A
Repair Type: Non-Urgent
Crossing Status: Indicator Found
UCIP Comments: 4/26/2016 Unable to access area near structure.5/14/2013 Same as last inspection.11/14/2012 Abandoned Structure: WS- reminince of gates and concrete standpipe; LS-reminince of concrete headwall and pump station.
FIELD_STRUCT_DESC: *ABANDONED* [Western Canal Head Gate Inlet Structure] 2 of 2: 72-inch by 96-inch (8-foot by 8-foot) reinforced concrete culvert through the levee 25 feet below the crown. Three slide gates on the waterside (WS) end. Concrete stairs on the WS slope. Concrete headwall at both toes. [Additional Reference(s): DWR Levee Log, 2005. USACE Sacramento O&M Manual 152, March 1957 (Station 170+00)]
FS Date: 5/3/2016 12:37:00 PM

View of levee crown looking downstream.

View of levee crown at a right bend.

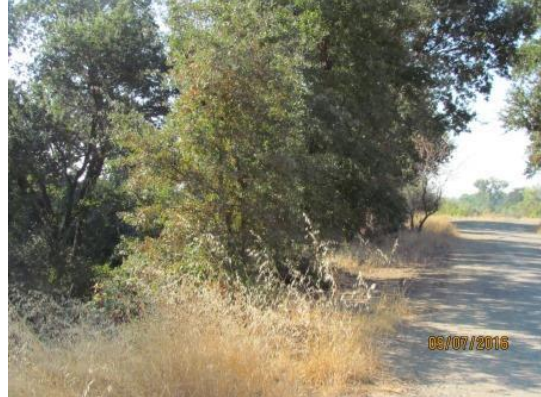
Photo 1 of 1 : FA_2016_ST0005_289_4_20160912_00010.jpg

LM Start	3.26	Rating **	M	Issue No.	4
LM End	3.27	Issue Type +	Ma	Location *	WS
Category	Earthen Levee			GPS Latitude/Longitude	
				Start	End
Item	Trim / Thin Trees			39.470433 °	39.470558 °
				-121.609200 °	-121.609215 °
DWR ID	DWR_ST0005_01_s _ 2013_4				
Comment Code					
T3 : Trim and thin trees to allow visibility of the ground and room to flood fight.					
Inspector Comment					
Small trees 4" in diameter at chest height should be removed before they get to big.

Waterside trees. Small trees 4" in diameter at chest height should be removed before they get to big.
